# **A COMPOSITES**

### **ALUCOBOND**<sup>®</sup> AXCENT

#### **DETAIL LEGEND**

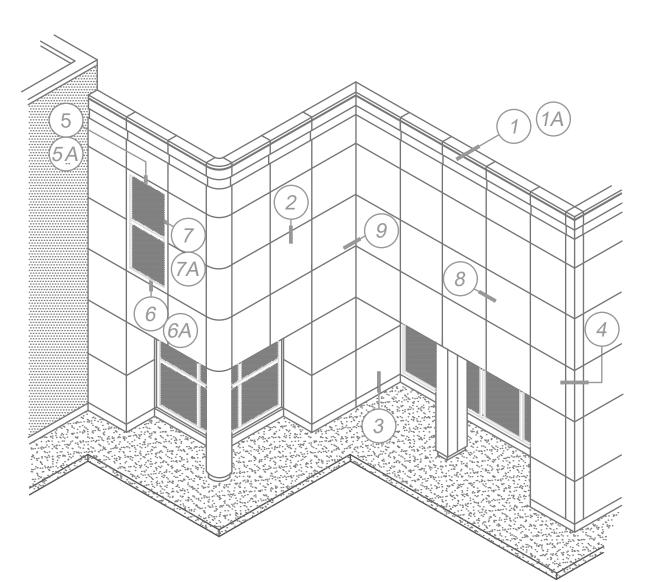
- 1 PARAPET CONDITION
- 1A PARAPET OPTIONAL
- <sup>2</sup> HORIZONTAL JOINT
- BASE CONDITION
   OUTSIDE CORNER
- 5 WINDOW HEAD
- 5a WINDOW HEAD OPTIONAL
- 6 WINDOW SILL
- 6a WINDOW SILL OPTIONAL7 WINDOW JAMB
- 7a WINDOW JAMB OPTIONAL
- 8 VERTICAL JOINT
  9 INSIDE CORNER

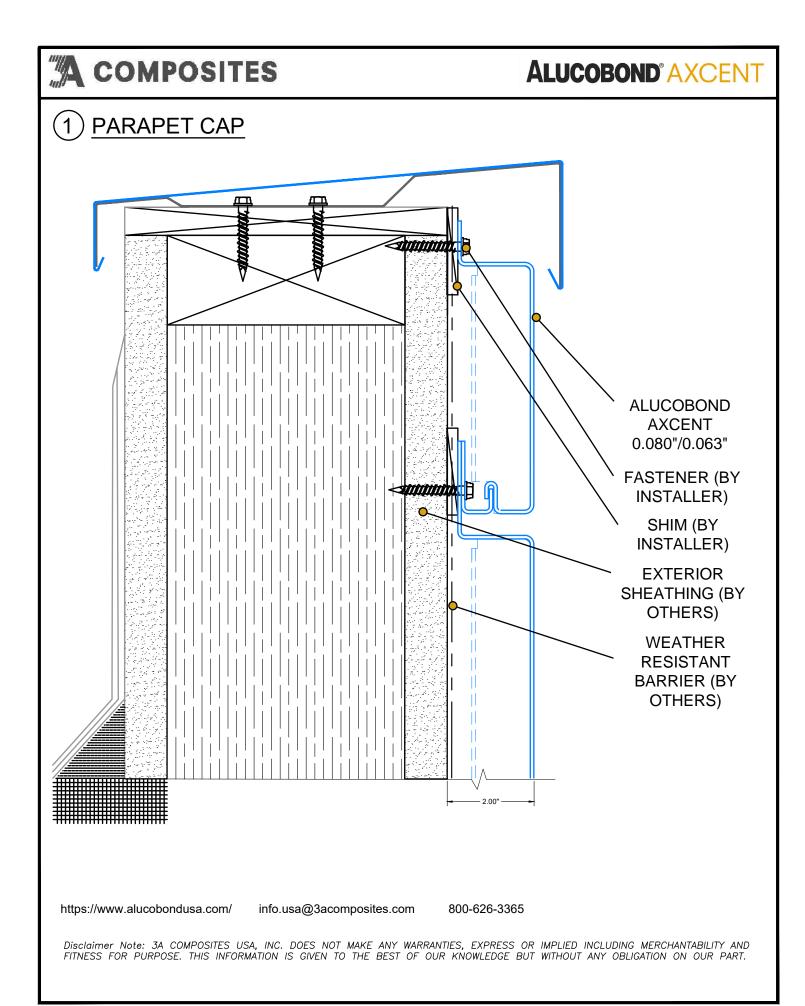
## **A** COMPOSITES **ALUCOBOND**<sup>®</sup> AXCENT 1 PARAPET CAP **Ammmul** ALUCOBOND AXCENT 0.080"/0.063" FASTENER (BY INSTALLER) 0 SHIM (BY **INSTALLER**) **EXTERIOR** SHEATHING (BY OTHERS) WEATHER RESISTANT **BARRIER (BY** OTHERS) 2.00" https://www.alucobondusa.com/ info.usa@3acomposites.com 800-626-3365 Disclaimer Note: 3A COMPOSITES USA, INC. DOES NOT MAKE ANY WARRANTIES, EXPRESS OR IMPLIED INCLUDING MERCHANTABILITY AND FITNESS FOR PURPOSE. THIS INFORMATION IS GIVEN TO THE BEST OF OUR KNOWLEDGE BUT WITHOUT ANY OBLIGATION ON OUR PART.
